- **ELECTRICAL—VEHICLE SPEED SIGNAL (VSS) INPUT NOTICED WHEN TESTING WITH NEW GENERATION STAR TESTER (NGS) WHEN VEHICLE IS STOPPED—SUPER DUTY F-53 MOTORHOME CHASSIS VEHICLES BUILT 1/2/1998 THROUGH 7/31/2000**
- **TRANSMISSION—4R100—TRANSMISSION STARTS OUT IN 2ND GEAR—ERRATIC 1-2 UPSHIFT OR ERRATIC 2-1 DOWNSHIFT FROM TRANSMISSION—SUPER DUTY F-53 MOTORHOME CHASSIS VEHICLES BUILT 1/2/1998 THROUGH 7/31/2000**

**Article No.
02-11-3**

FORD: 1999-2000 SUPER DUTY F-53 STRIPPED CHAS.

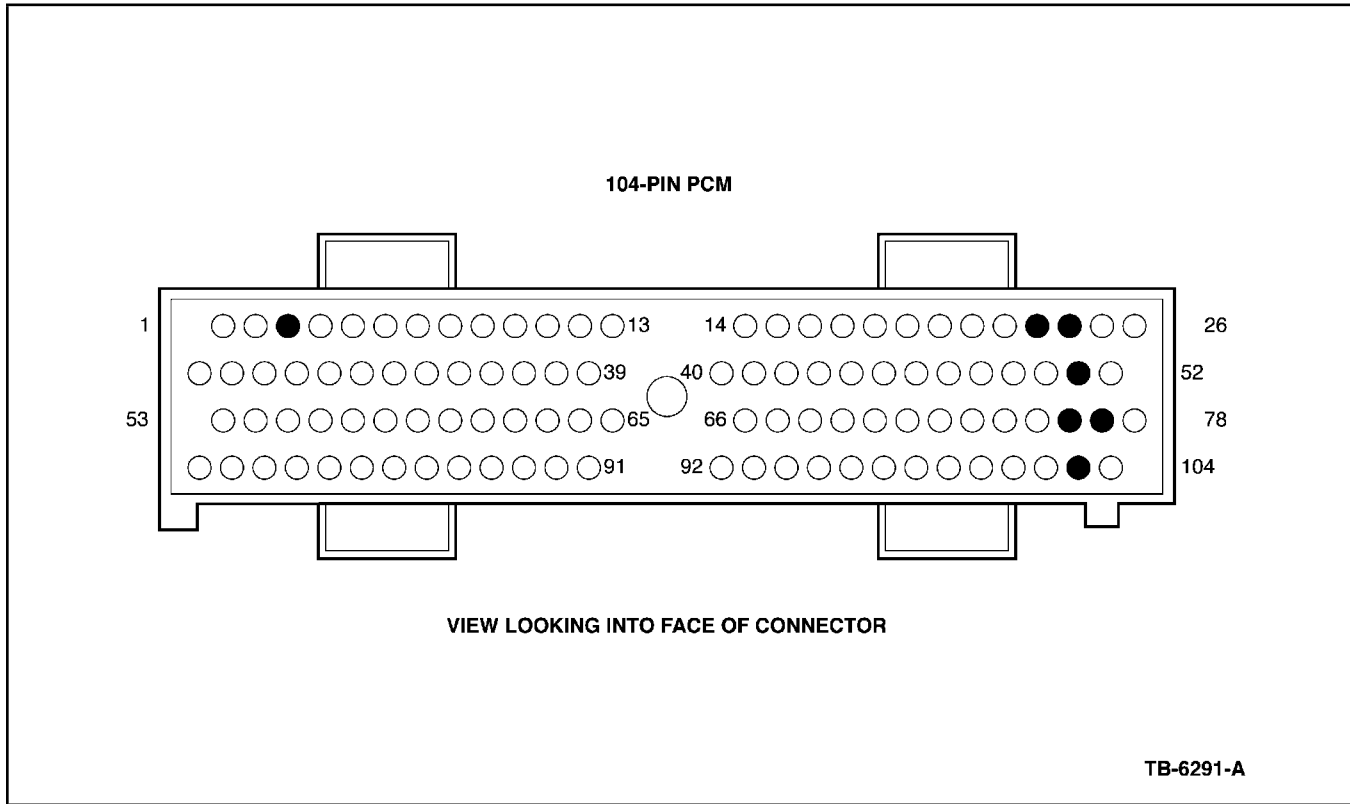
Figure 1 - Article 02-11-3

4. Bolt the original ground eyelets to the sheet metal using this new hole (Bolt: N805503-S301 and Nut: N620480-S301).
5. Remove the PCM connector.
6. Remove the black plastic shield from the back of the PCM connector.
7. Remove the red locking plate from the front of the connector.
8. Using the sharpened paper clip tool (or small screwdriver), open the locking tabs and remove the pins as shown (Figure 1).

TO INSURE THE CORRECT PINS WERE REMOVED, THE RESISTANCE SHOULD BE "0" OHMS BETWEEN ALL SEVEN (7) PINS.

9. Insert the seven (7) pins from the new Jumper Harness (1C3Z-13N850-AA) into the connector. Reinstall the red locking plate.
10. Install the eyelet from the new Jumper Harness (1C3Z-13N850-AA) into the ORIGINAL hole (weldnut).
